# **POP Piston Ring Pack**

New standard for piston top ring

SL12-562/JAP June 2012

Owners and operators of 26-50 small bore MAN B&W two-stroke marine diesel engines. Type: MC/MC-C, ME/ME-C/ME-B and ME-GI

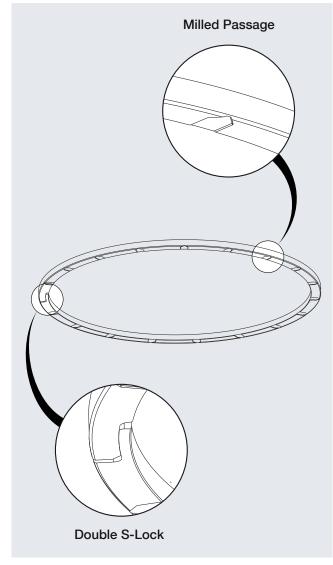
Fig. 1: CPR-POP piston ring

We have observed areas with premature wear out of the controlled leakage (CL) grooves on the top ring running surface. As a result, the pressure drop over the top ring increased further, resulting in increased wear on the top ring, high liner wear rate and increased ring groove wear.

The main configuration with the double S-lock and gas relief grooves remains unchanged. The CL grooves on the runing side have been omitted and replaced with a number of ports milled into the lower side of the piston ring, see Fig. 1.

These passages have been configured with a 90 degree narrowing, causing the ring to increase the bypass area as the ring wears, instead of reducing it when the minimum depth is reached, as is the case with the CL grooves. Thereby, the pressure drop decreases instead of increases.

To eliminate the negative influence from worn-out (CL) grooves, we have tested an alternative ring type to replace the CPR-CL ring. This new ring type is called CPR-POP (Port-On-Plane).

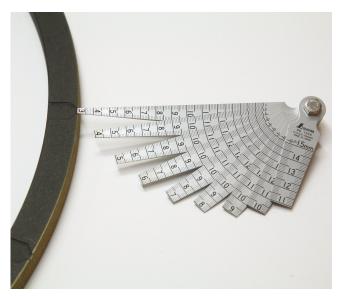
Fig. 2: Feeler-gauge-type measuring tool

To measure the wear of the ring, the width of the leakage passage can be measured using a feeler-gauge-type measuring tool, see Fig. 2. The opening is 3 mm from the beginning, and the milled passage is designed in such a way that for every 1 mm the ring is worn radially, the gap opens 2 mm. Table 1 lists the maximum allowable width of the leakage gap for our small bore engines.
